# Manhole Inspection Summary

Manhole # S39Y1\_017MH

Insp Date: **11/19/07 7:41 AM**

**Location** Address: **3616 6th St**

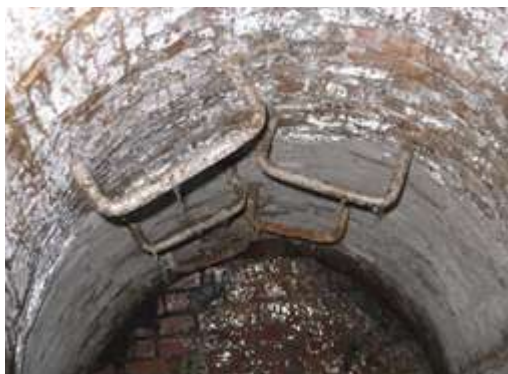
steps

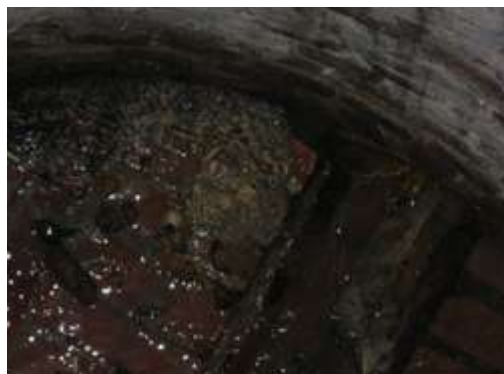
Defect 2

debris

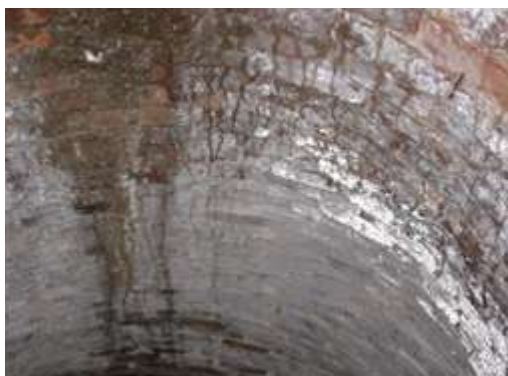
Defect 1

Infiltration: ☐ None ☐ Joint ☐ Cracks ☐ Mortar ☐ Roots ☒ **Wall**

white film on walls

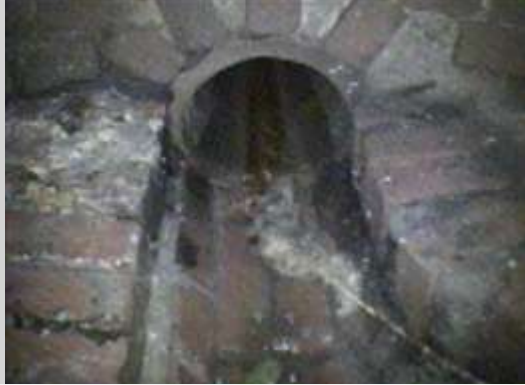
12 O'Clock Outflow

8 in. Circular Gravity Sewer  
Pipe Out @ 12 O'Clock

Pipe Height: **10.8** (in.) Rod and Bar (Angled)  
Pipe Material: **Clay** ☐ Pipe Lined  
Invert Depth: **10.10** (ft.) Flow Characteristics: **Fast**  
Deposits: ☒ None ☐ Mud ☐ Sludge ☐ Debris ☐ Grease  
Silt Depth: (in.) Deposits Extent:  
Infiltration: **None** Pipe Seal Cond: **Sound**

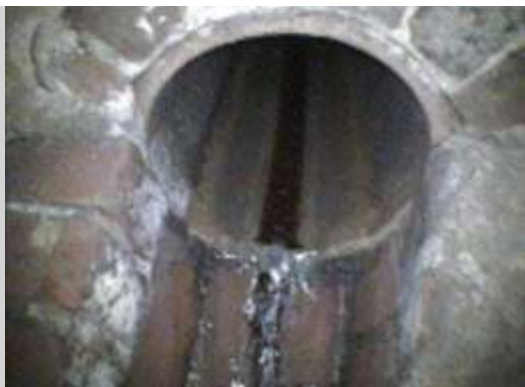
3 O'Clock Inflow

8 in. Circular Gravity Sewer  
Pipe In @ 3 O'Clock

Pipe Height: **9.6** (in.) Rod and Bar (Angled)  
Pipe Material: **Clay** ☐ Pipe Lined  
Invert Depth: **9.20** (ft.) Flow Characteristics: **Fast**  
Deposits: ☒ None ☐ Mud ☐ Sludge ☐ Debris ☐ Grease  
Silt Depth: (in.) Deposits Extent:  
Infiltration: **None** Pipe Seal Cond: **Sound**

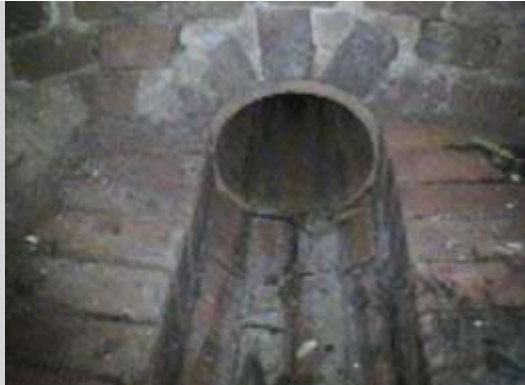
6 O'Clock Inflow

8 in. Circular Gravity Sewer

Pipe In @ 6 O'Clock

Pipe Height: **10.8** (in.) Rod and Bar (Angled)

Invert Depth: **10.06** (ft.) Flow Characteristics: **Slow**

Infiltration: **None** Pipe Seal Cond: **Sound**

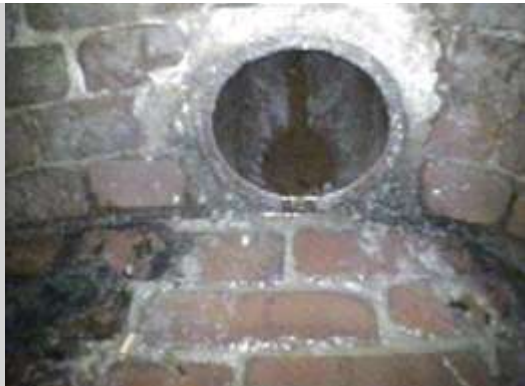
9 O'Clock Inflow

6 in. Circular Service Sewer

Pipe In @ 9 O'Clock

Pipe Height: **7.2** (in.) Rod and Bar (Angled)

Invert Depth: **9.19** (ft.) Flow Characteristics: **Slow**

Infiltration: **None** Pipe Seal Cond: **Sound**
